Building Information - Shaker Heights City SD (44750) - Onaway Elem

Program Type	Classroom Facilities Assistance Program (CFAP) - Regular
Setting	Urban
Assessment Name	Copy of Assessment Report automatically generated for Kelton Waller
Assessment Date	2014-04-30
Cost Set:	2014
Building Name	Onaway Elem
Building IRN	28647
Building Address	3115 Woodbury Rd
Building City	Shaker Heights
Building Zipcode	44120
Building Phone	(216) 295-4080
Acreage	22.00
Current Grades:	K-4
Teaching Stations	31
Number of Floors	3
Student Capacity	477
Current Enrollment	428
Enrollment Date	2014-04-30
Enrollment Date is the date in which the current enrollment was taken.	
Number of Classrooms	22
Historical Register	NO
Building's Principal	Amy Davis
Building Type	Elementary

Building Construction Information - Shaker Heights City SD (44750) - Onaway Elem (28647)

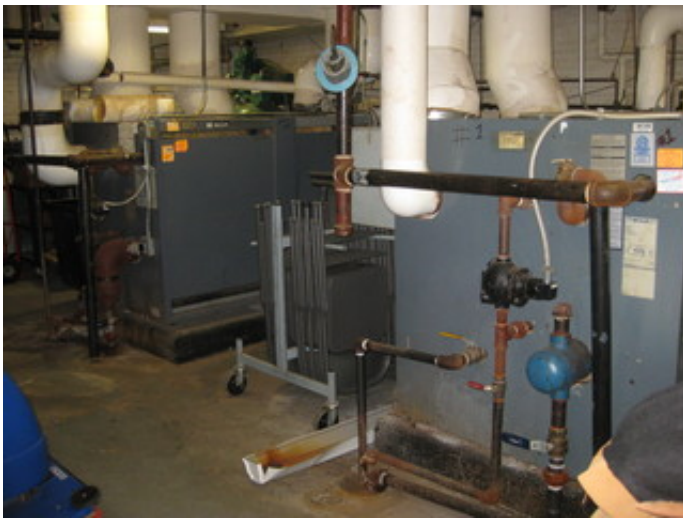
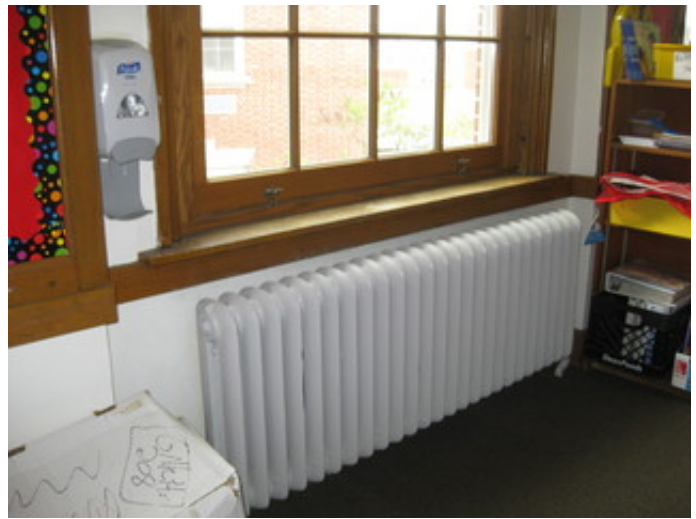
Description: The existing system for the building consists of three Weil-McLain steam boiler at 1690 MBH each installed in 2001. The boilers appear to be in satisfactory condition. The older part of the building, 1922, is all steam heat to fin tube or radiators, or air handling units with steam coils. The 1923 building central ventilation fans were not functioning at the time of the visit. However, the staff indicated the largest ventilation fan that is ducted to each classroom did have the motor/belt replaced. This ventilation system also has a steam heating coil that has not functioned for several years, so the fan only operates in less than freezing temperatures. There is a tube and shell steam to hot water heat exchanger in the mechanical room with two heating water building pumps that serve the unit ventilators and air handling units in the 1991 section of the building. The one pump was replaced in 2012 and the other pump was replaced in 2013 and both are in good condition. There is normal corrosion on the heat exchanger due to age. The boilers and air handling units are controlled with DDC controls and the rest of the controls are pneumatic and in fair to poor condition due to the equipment age. Generally, all the equipment has been well maintained. Each ventilator in the new wing has an outside air grilled at the exterior wall. Overall, the ventilators and the air handling unit for the 1991 section of the building may provide the required outside air delivery to meet OBC mechanical code. The 1923 section of the building does not meet the outside air requirements. The DDC controls were added two years ago under an energy performance contract. The staff indicates they turn off the boilers on mild temperature days to avoid over heating the school, but generally they try to leave the controls enabled. The steam or two-pipe system does not provide a capacity for simultaneous heating and cooling operation which is not compliant with the OSDM requirements. The staff indicated that the site does not contain underground fuel tanks.

Rating: 3 Needs Replacement

Recommendations: Provide a new overall heating ventilating and air conditioning system to achieve compliance with OBC and OSDM standards. Convert to ducted system to facilitate efficient exchange of conditioned air. Provide new DDC temperature controls with the new system. The new ducted system will likely require architectural soffits to accommodate the installation of the ductwork.

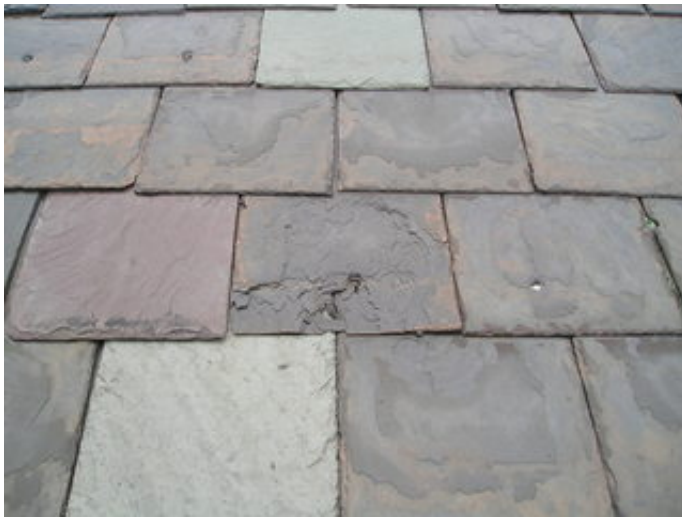
Description: Low sloped area of the roof are covered by built-up roofing and a reflective top coat. The built-up roof has passed its expected service life. Pitched roofs are covered with original shingles. The outside edge of the pitched roof drains to metal lined box gutters. The interior edges of the roof drain on to the low-sloped roof which is served by area roof drains. The gutters and downspouts are original to the building and have exceeded their expected service life. Numerous replaced, damaged, and missing shingles were observed on the original pitched roof. Several repairs have been made to the low-slope roof where slate shingles have fallen and damaged the built-up roofing. The roof over the original building is accessed via a manually operated hatch accessed by a ladder from the second floor.

Damaged and replaced slate tile

Recommendations: Provide new asphalt shingle roof over the pitched roof areas of the 1922 building. Replace the built-up roof and provide new overflow drains. Provide new flashings around stacks and dormers at the pitched roofs as necessary to replace damaged areas of flashing. Provide new gutters and downspouts around the original 1922 building.

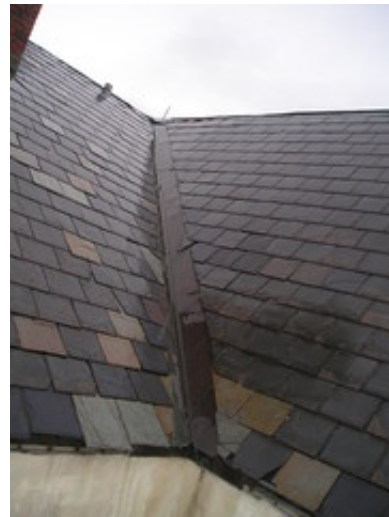
Damaged and replaced slate near valley

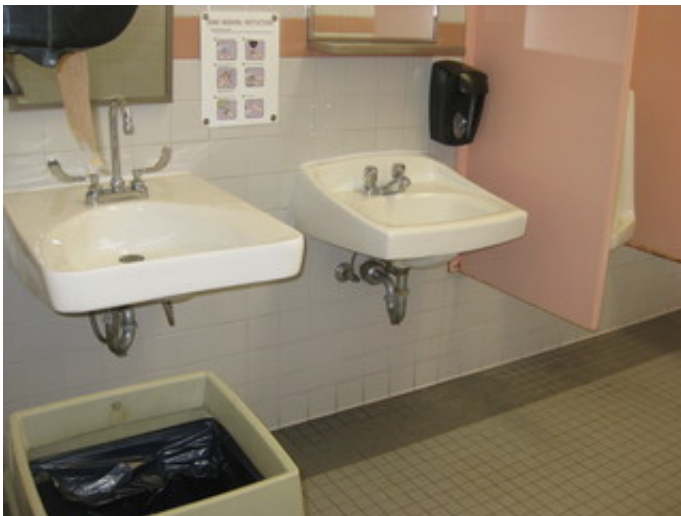
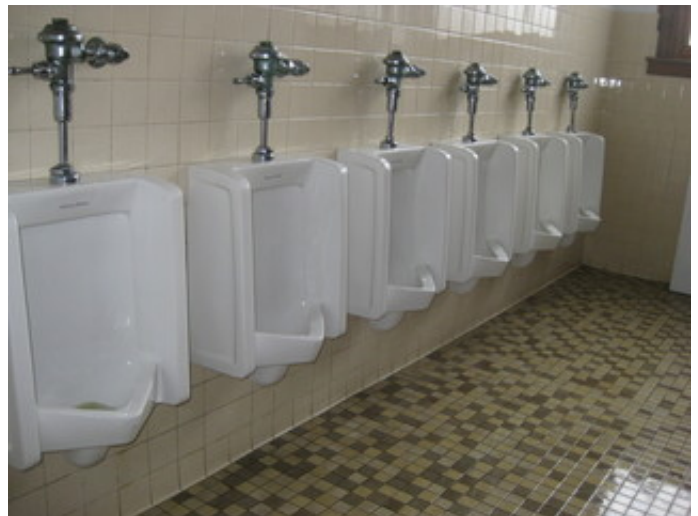
Description: The 4" domestic water supply piping in the original building is galvanized piping at the building entrance. The water piping in the building is estimated to be 75% galvanized and 25% copper in fair condition. There is a pressure reducing valve on the water service line but there is no backflow preventer. The pressure reducing valve appears to be in poor condition. There were no water pressure issues indicated by the staff. A water treatment system is not required for the domestic water system. There is a small water softener for the boiler water make-up. A 2013, Lockinvar 75.1 MBH water heater with storage tank provides the domestic hot water for the main building. The recirculation pump was replaced this year. There are no electronic sensor faucets and flush valves in the building. All of the toilets are floor mounted. The plumbing fixtures are generally in good condition. The school contains 5 restrooms for boys, 5 restrooms for girls, and 5 restrooms for the staff. The second floor of the addition 1 boys ADA restroom and 1 girls ADA restrooms. There are 23 LAVs, 3 ADA LAVs, 42 toilets, 3 ADA toilets, 15 urinals and 1 ADA urinals. There are 18 classroom sinks; the sink is in good condition, the faucet is in fair to poor condition. The LAVs have metering faucets in fair to poor condition and showing age. There are 5 electric water coolers in the school in generally good condition. There is no kitchen in this school.

Rating: 3 Needs Replacement

Recommendations: Provide new low flow fixtures with low flow faucets and flush valves with sensors, to meet OSFC requirements. The boys and girls restroom LAV's will be replaced with a two station modular lavatory. Replace all of the galvanized piping and the electric water coolers. Replace all of the classroom sink faucets.

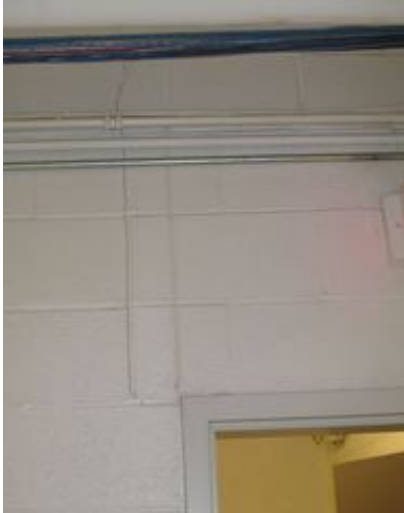
Description: While the building is not visible at its footings, the basement of the 1991 wing reveals cracks in the floor, walls and ceilings which are potentially from differential settlement. Additionally, maintenance personnel reported that water breaches the basement walls.

Cracking is present over this door frame in the basement.

Recommendations: Provide sump pumps and foundation drain tile system to evacuate ground water from around the 1922 building.

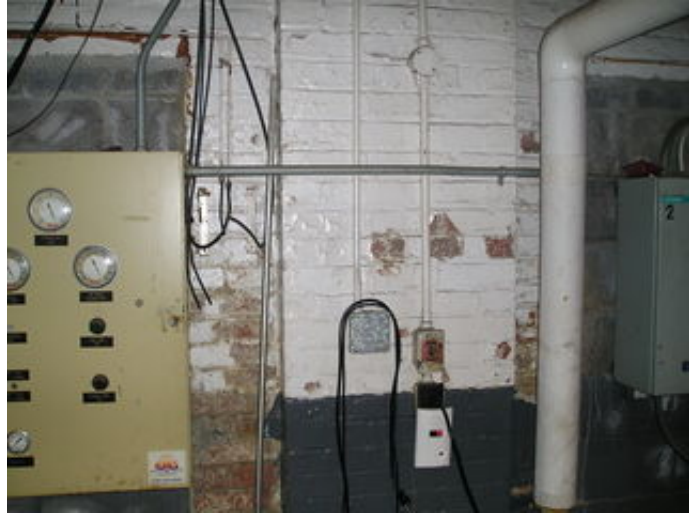
Evidence of water breach is seen at this basement wall.

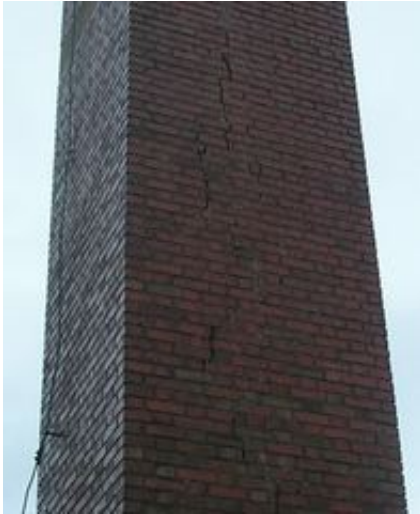
Cracks and mortar wash-out are visible on this chimney

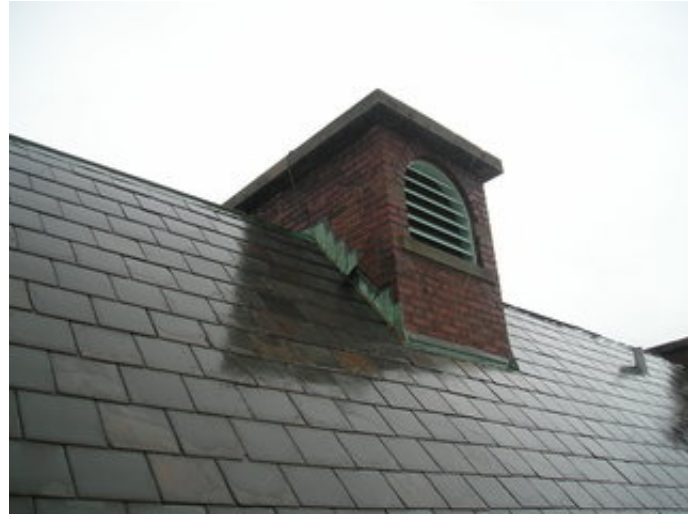
Flashing is damaged at this dormer

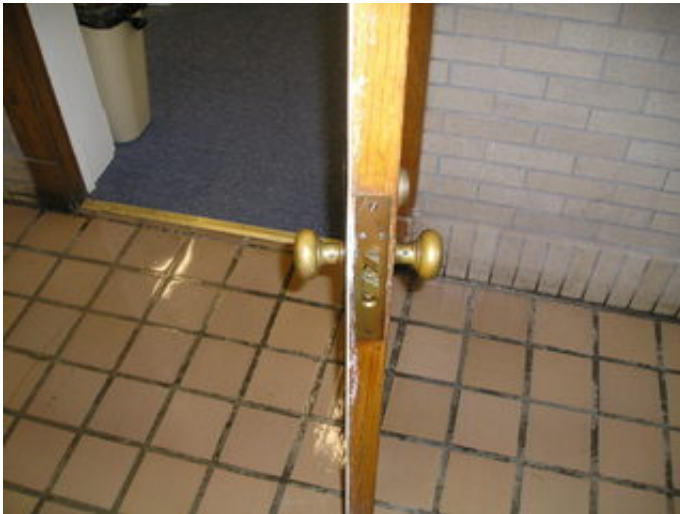
Replace with lever type hardware

Recommendations: Provide a wheelchair lift to access the stage. Provide new lever type hardware in the original building. Provide high contrast signage with embossed braille.

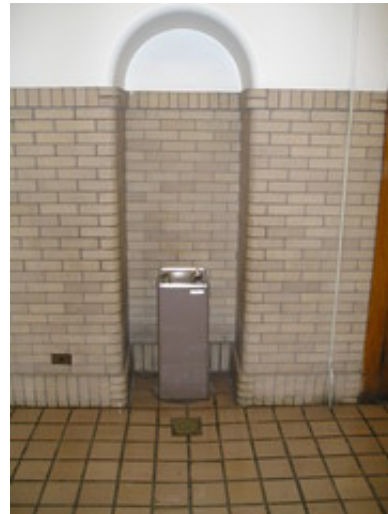
Non-accessible drinking fountain in original 1922 building.

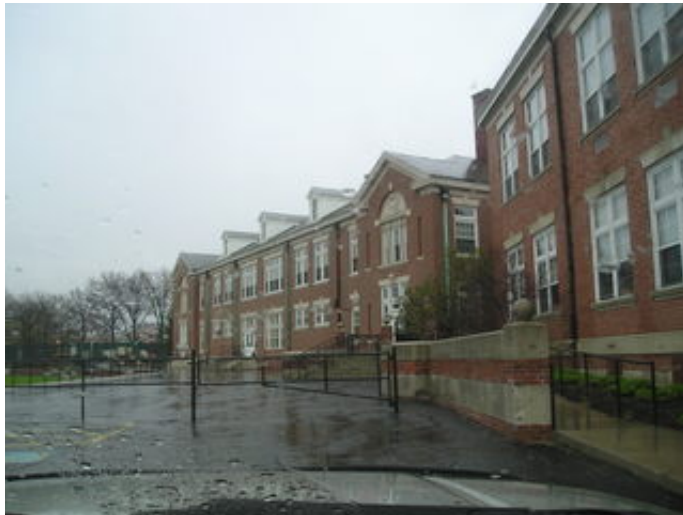
Description: Overall the site is in good condition. Sidewalks are in tact and parking lots are without driving or tripping hazard. Adequate parking is provided for staff. There is no separation between bus drop and drop-off from other vehicles. Adequate playground equipment is provided and observed to be free from hazard. The parking lot has only 60 of the OSDM recommended 76 spaces for a school of this size. A concrete dumpster pad is provided. However it is not large enough to capter the weight at the truck axles.

No vehicular drop-off

Recommendations: Provide a clear delineation between bus circulation and circulation for other vehicles. Provide a new concrete dumpster pad large enough for trash removal vehicles.

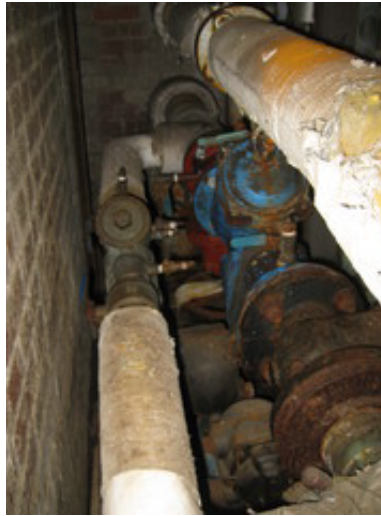
Description: The 4" domestic water supply piping in the original building is galvanized piping, and is located next to the steam coil, in the outside intake area for the 1923 Building ventilation fan. It appears that this pipe may have the potential to freeze if the fan is in operation during outside air temperatures below freezing. The isolation valves in this system no longer hold tight. If there is a leak, the entire building water system must be shut down. The water piping in the building is estimated to be 75% galvanized and 25% copper. There is a pressure reducing valve on the water service but there is no backflow preventer. The corrosion on the pressure reducing valve indicates it is close to the end of its useful life. The system provides adequate pressure and capacity for the facility's needs. There is an automatic fire suppression system for the Basement only, computer room and small library area. This area was once a storage room. The existing water supply system will not provide adequate support for a future fire suppression system.

Rating: 3 Needs Replacement

Recommendations: Replace water main to meet the sprinkler requirements and install a backflow preventer.
